EVALUATION OF REDESIGNED XW18 MEMBRANE
AND ACCESSORIES

TECHNICAL REPORT S-73-3

Conducted by U. S. Army Engineer Waterways Experiment Station
Soils and Pavements Laboratory
Vicksburg, Mississippi

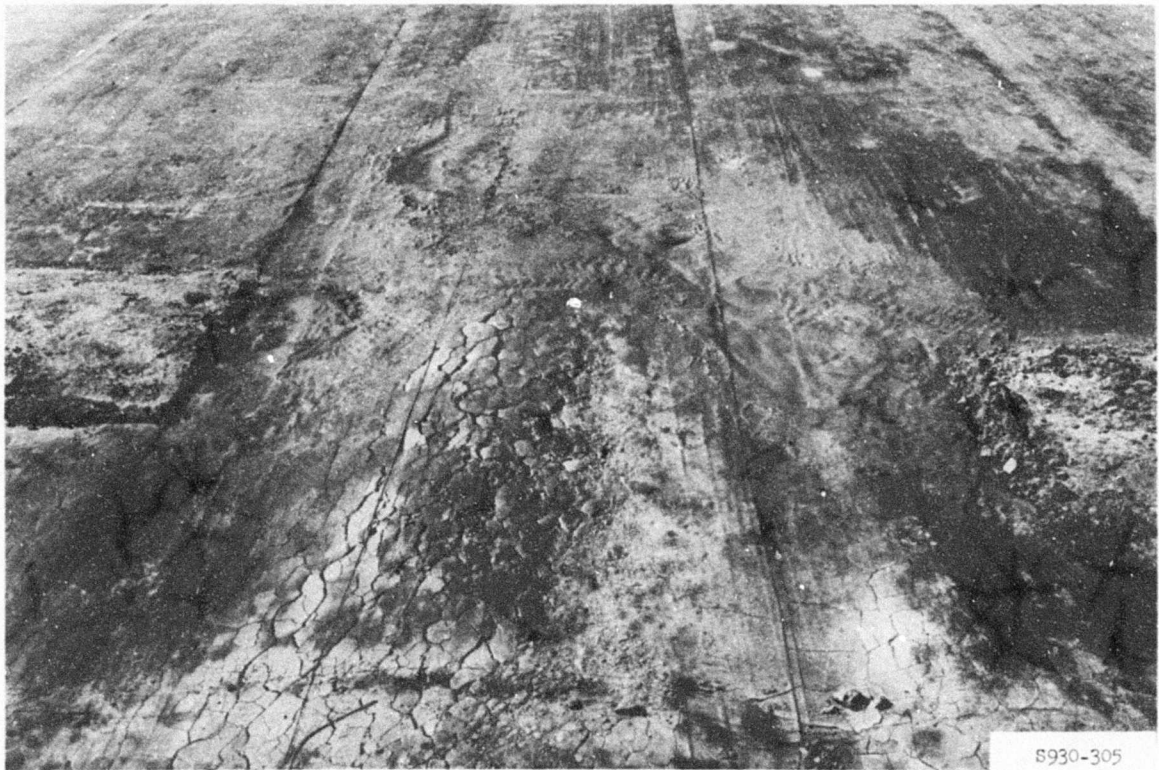
Photo 59. Condition of lean clay subgrade of test section 1, sta 1+05, after 538 coverages

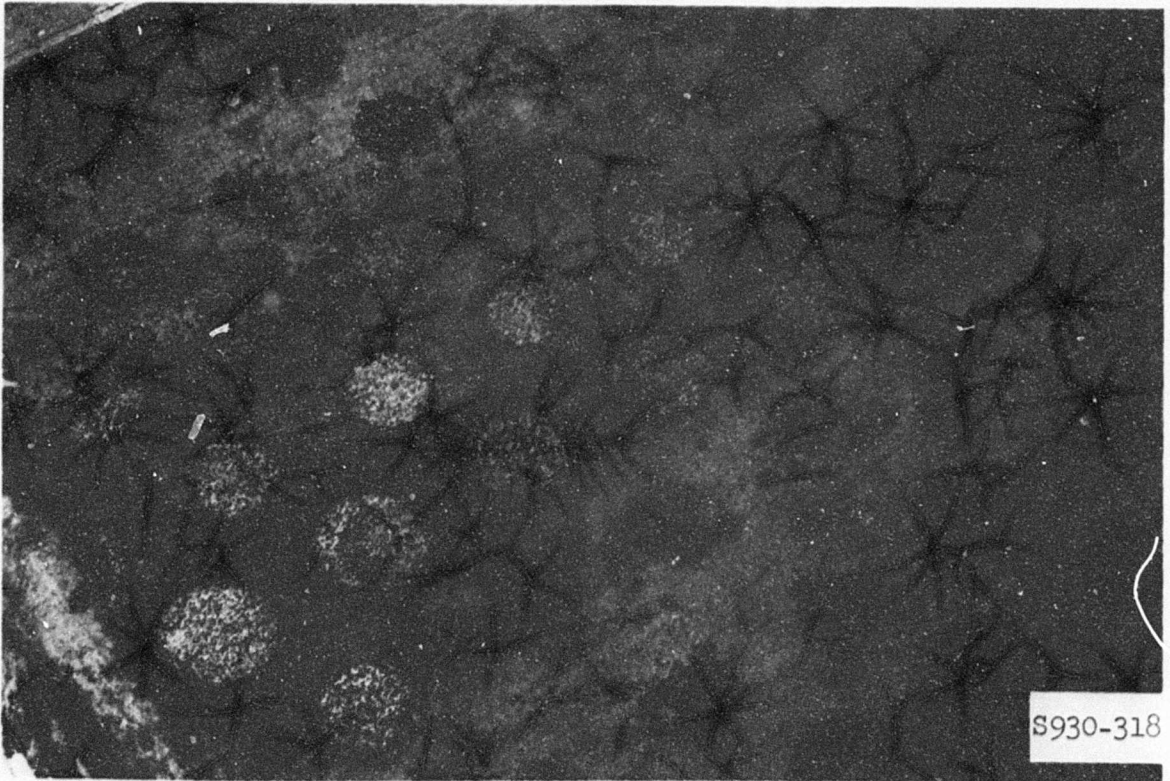
Photo 67. Closeup view of wear on sheet 1 of test section 1
(738 coverages)

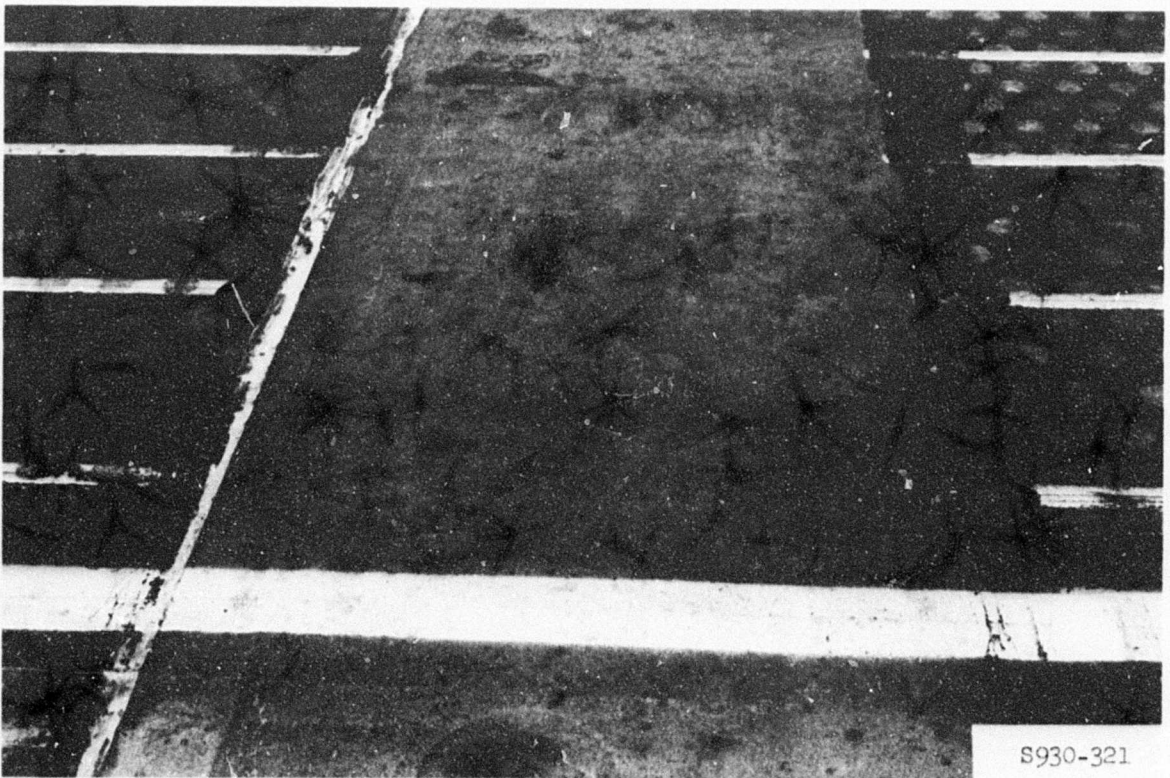
Photo 68. General condition of Weatherban 101 sealant (left edge of
joint) and EC801 sealant (right edge of joint) after 200 coverages
on sheet 3A of test section 1

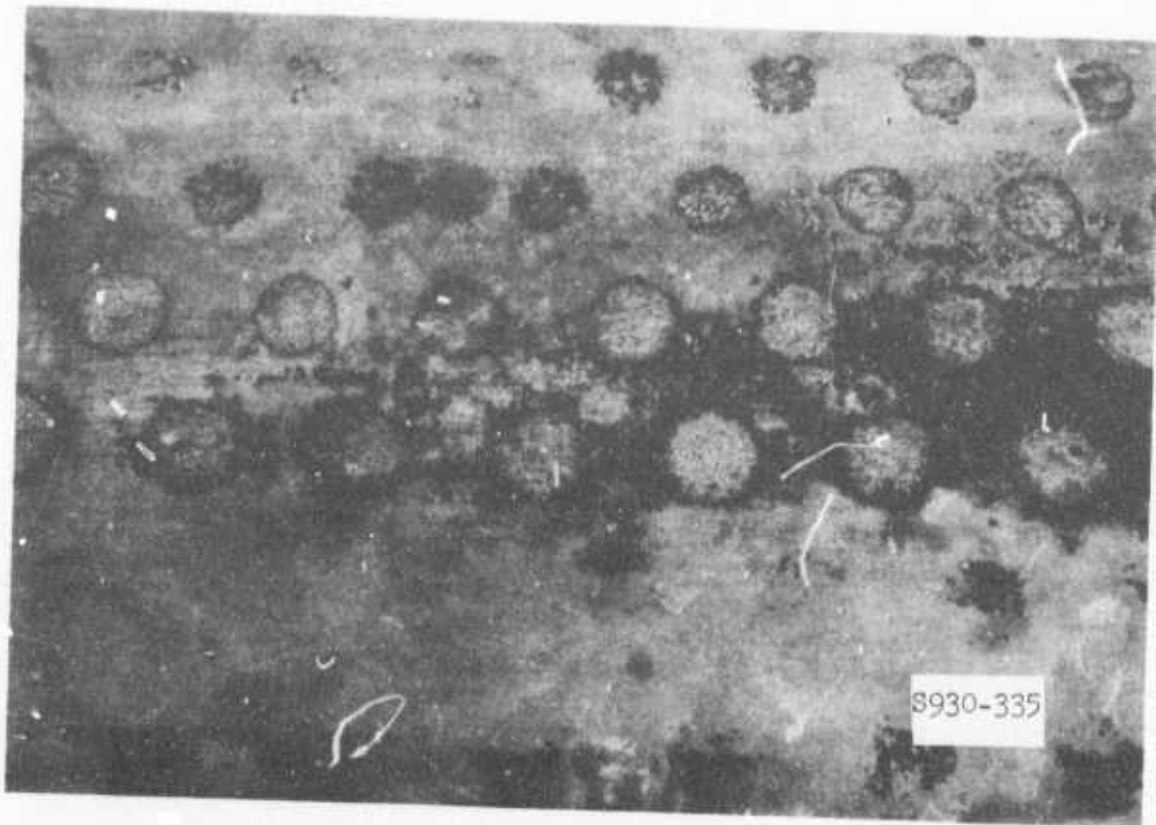
Photo 75. Severe wear of neoprene coating on sheet 1 of test section 1
(1200 coverages)

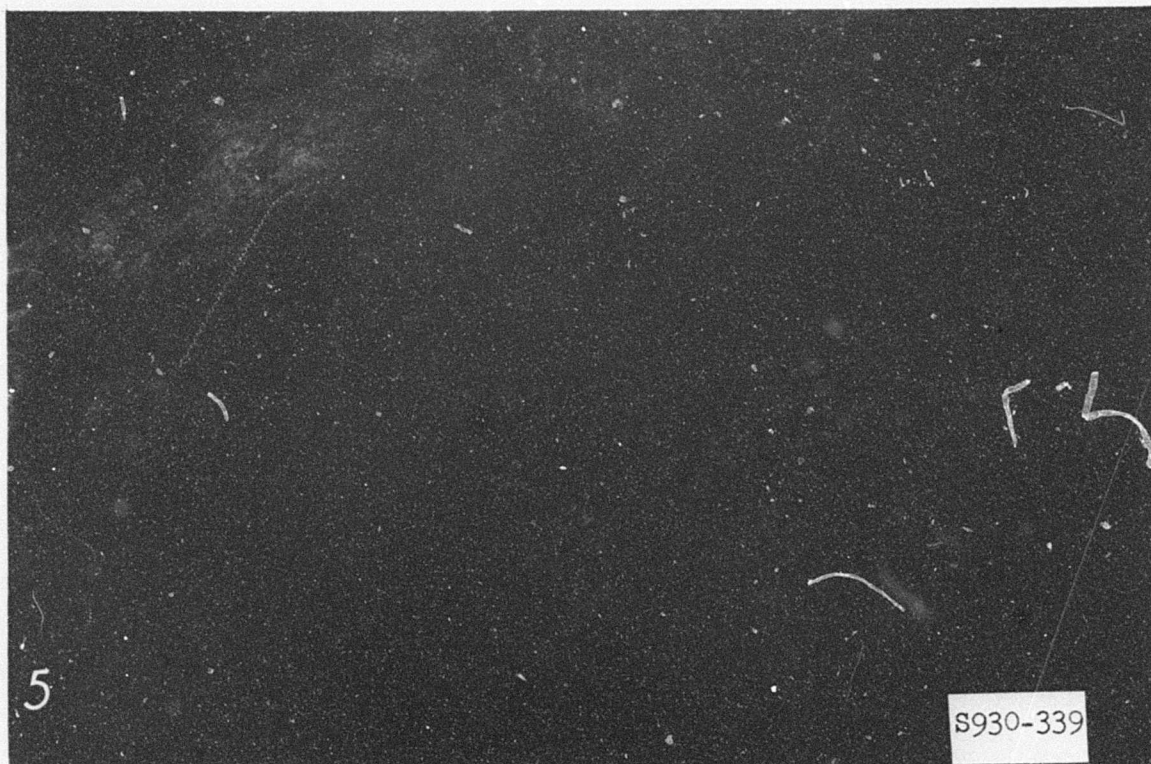
Photo 77. Typical wear on membrane sheet 3A of test section 1 after 662 coverages (1200 total coverages on test section)

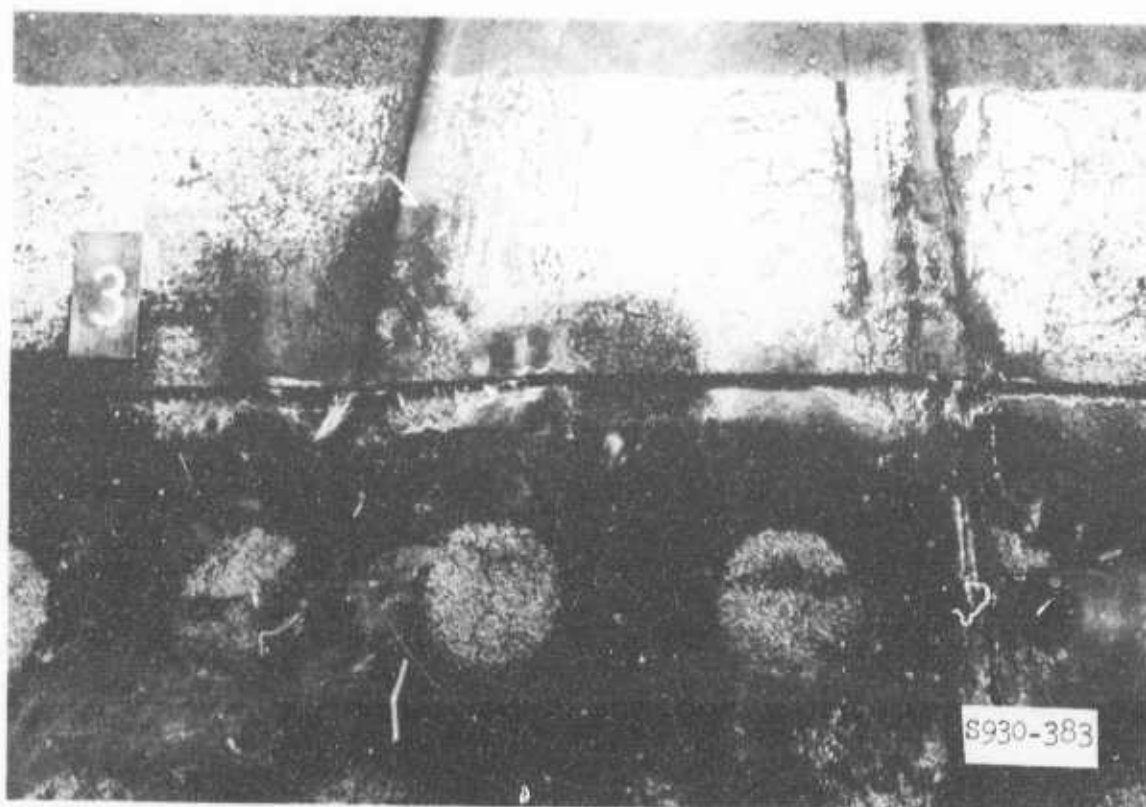
Photo 81. Peeling of 6-in.-wide factory fabrication joints on test section 2 at 200 coverages
